Manhole Inspection Summary

Manhole # S59U__001MH

Insp Date: **4/30/08 2:19 PM**

Location Address: **1717 S. Newkirk St.**

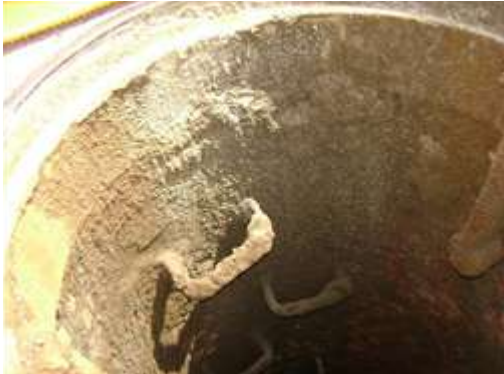
Defect 1

Signs of infiltration at MH cover.

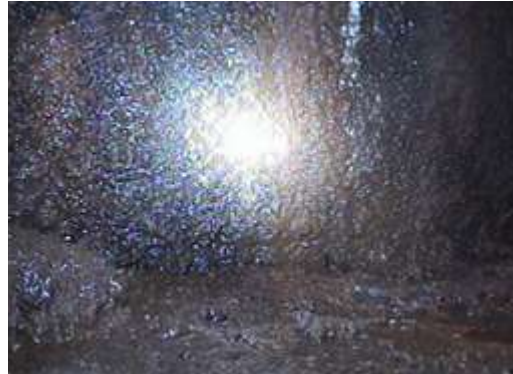
Defect 3

Possible infiltration on walls, no concrete evidence. May be condensed gas vapors.

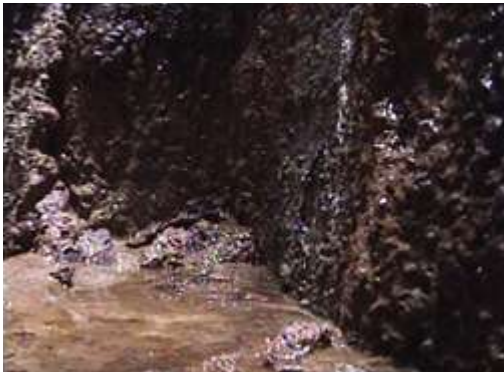
Defect 2

Infiltration at base of barrel wall.

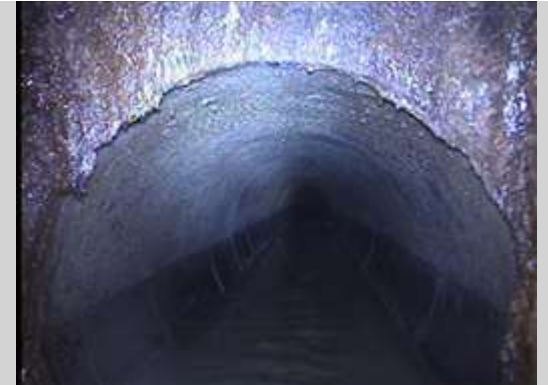
12 O'Clock Outflow

33 in. Circular Gravity Sewer
Pipe Out @ 12 O'Clock

Pipe Height: **32.4** (in.) Rod and Bar (Angled)
Pipe Material: **Clay** ☐ Pipe Lined
Invert Depth: **21.58** (ft.) Flow Characteristics: **Fast**
Deposits: ☐ None ☐ Mud ☒ **Sludge** ☒ **Debris** ☐ Grease
Silt Depth: **3** (in.) Deposits Extent: **Heavy**
Infiltration: **None** Pipe Seal Cond: **Sound**

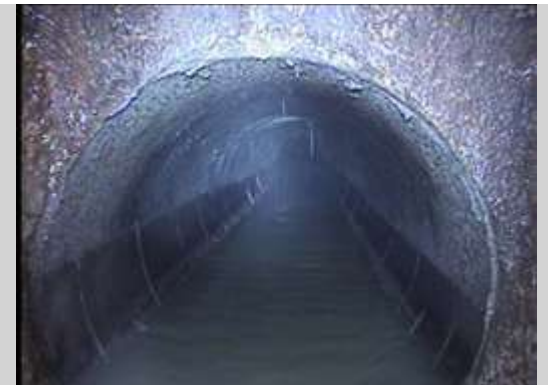
6 O'Clock Inflow

33 in. Circular Gravity Sewer
Pipe In @ 6 O'Clock

Pipe Height: **32.4** (in.) Rod and Bar (Angled)
Pipe Material: **Clay** ☐ Pipe Lined
Invert Depth: **21.33** (ft.) Flow Characteristics: **Fast**
Deposits: ☐ None ☐ Mud ☒ **Sludge** ☒ **Debris** ☐ Grease
Silt Depth: **3** (in.) Deposits Extent: **Heavy**
Infiltration: **None** Pipe Seal Cond: **Sound**
